19 September 2012

Re: **Chevron Richmond Refinery Crude Unit Fire of 6 August 2012**

CBE Letter on Chevron Crude Unit Fire 19 September 2012

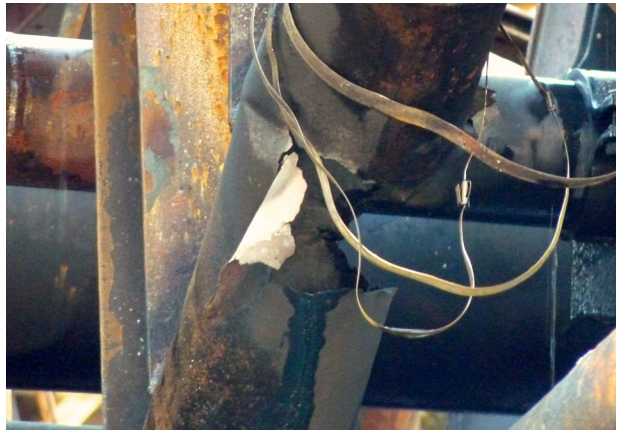
- The 6 August fire started when a carbon steel pipe section in the crude unit that had lost 80% of its pipe wall thickness due to corrosion ruptured, releasing hot (~680 °F) gas oil that vaporized and ignited.⁴ (See Figure 1.)
- Before this 6 August pipe failure, another corroded pipe section on the same gas oil line was replaced in November 2011,⁴ and yet another carbon steel pipe failed due to corrosion in yet another major crude unit fire on January 15, 2007,⁵ demonstrating a pattern of pipe corrosion problems in the crude unit.

Figure 1. The pipe rupture involved in the 6 August Richmond crude unit fire. Photo CSB.

This letter renews and further supports CBE's urgent request that the City fully utilize its authority to ensure that damaged and unsafe equipment involved in the 6 August fire, including the refinery's crude unit, is rebuilt using the safest and least-emitting equipment designs and construction materials available.

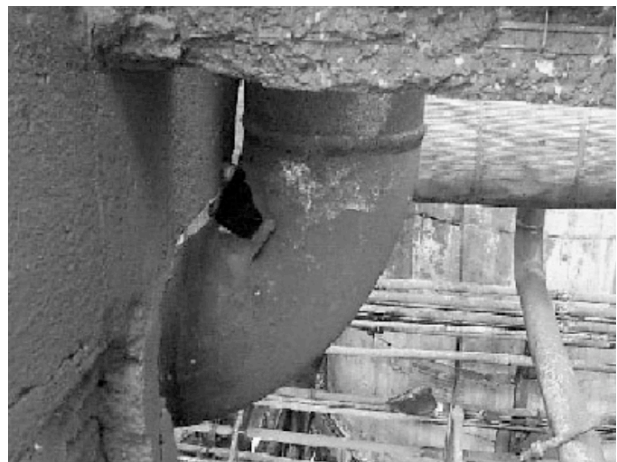
- Sulfur corrosion (“high-temperature sulfidation”) is a well known problem in refineries, and in refinery crude distillation units specifically.^{6–12} (See Figure 2.)

Figure 2. Sulfidation corrosion failure of a pipe elbow at another refinery. Photo API (2003).

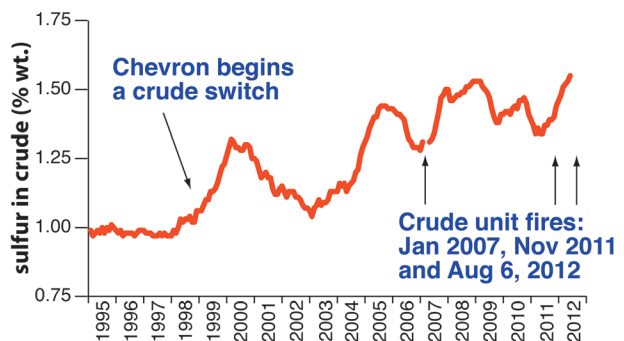
- The sulfur content of the Richmond refinery crude feed increased substantially, forcing roughly *180 tonnes/day more sulfur* through the crude unit during the 12 month period ending May 31, 2012 than in the years before Chevron began a switch from Alaskan to Persian Gulf crude oils in 1998. (See Figure 3.)

Figure 3. Sulfur in crude refined at Richmond, January 1995–May 2012. Rolling annual average of monthly data from USEIA and Chevron. Chart by CBE.
