Widespread corrosion at the Richmond Refinery

This page: The pipe that ruptured in Chevron's disastrous August 2012 fire (point 1 below) is just one of at least twenty known places where corrosion damaged equipment in its crude unit alone.

page two

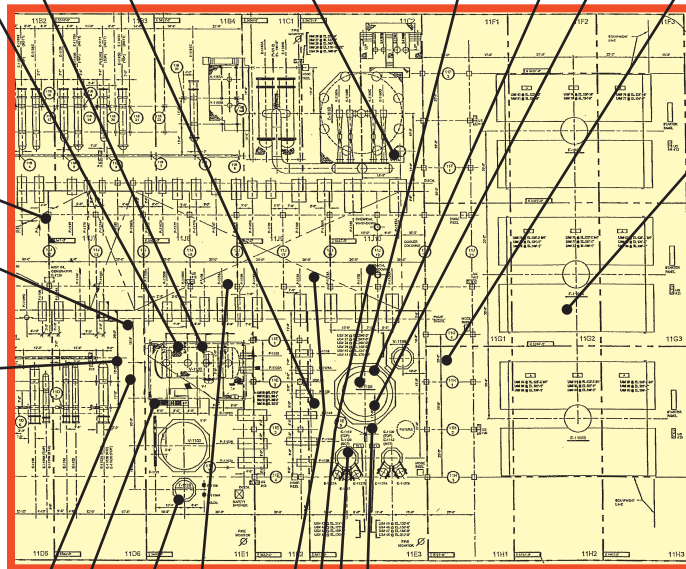
1. #4 sidecut pipe from atmospheric column C-1100 to pumps P-1149/A: sulfidation corrosion leads to rupture in Aug. 2012 fire

5. Atmospheric reflux drum V-1100 shell: internal corrosion

8. Relief piping for atmospheric reflux drum V-1100: 43% of pipe wall is lost to external crevice corrosion

10. #7 sidecut pipe from pumps P-1179 & 1189A to exchanger E-1109: sulfidation corrosion repairs

11. Atm. overhead pipe from E-1101 to condenser: external corrosion pitting

12. Atm. overhead pipe from E-1100 to V-1100: extensive internal corrosion pitting, found after fire-damaged pipe removed, suggests a failure risk before the next scheduled shutdown

13. FT-007 tubing between reflux drum V-1100 & exchanger E-1100: corrosion at compression fitting

15. Reflux drum V-1100 pH sample pipe & tubing: repeated plugging suggests corrosion upstream

17. Aqueous ammonia tank TK-1108: underside & internal corrosion

18. Atm. overhead pipe from C-1100 to E-1101: external corrosion, bulging & delamination

20. Condensate pipe adjacent to C-1100 & pumps P-1105/A: corrosion under insulation

2. Atmospheric overhead pipe from C-1100 to relief header: extensive internal corrosion pitting, found after fire-damaged pipe was removed, suggests a failure risk before the next scheduled maintenance shutdown

6. Condensate pipe downstream from vessel V-1164: internal & external corrosion & leaks

3. Atmospheric column C-1100 shell: corrosion under insulation

4. Atmospheric column C-1100 pressure taps PT 001 & 003: internal pitting corrosion

7. C-1100 crude feed pipe from furnaces F-1100A/B: internal weld corrosion after repair from naphthenic acid corrosion

9. Smothering steam piping for furnace F-1160 firebox: localized corrosion found since 2006

14. Stripping steam pipe to atm. column C-1100: corroded & leaking

16. Stripping steam piping to column C-1130: corrosion under insulation thins pipe to 50% of recommended replacement thickness

19. Medium-pressure condensate header piping: corrosion under insulation
